Columbia Crew Survival Investigation Report

NASA/SP-2008-565

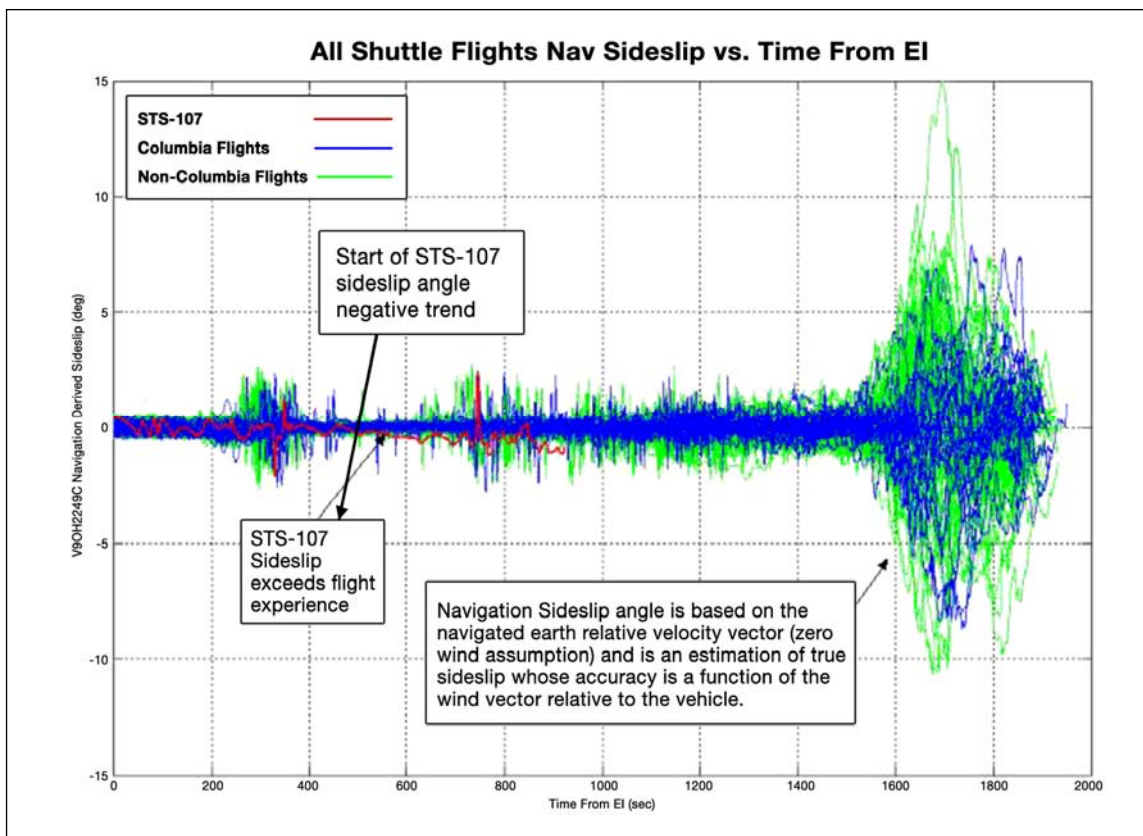
Figure 1.1-10. Negative trend starts at GMT 13:51:46 (EI+457) and exceeds flight experience at GMT 13:53:38 (EI+569).¹¹

At GMT 13:53:38 (EI+569), the sideslip angle (left yaw) exceeded all previous flight experience (figure 1.1-10).

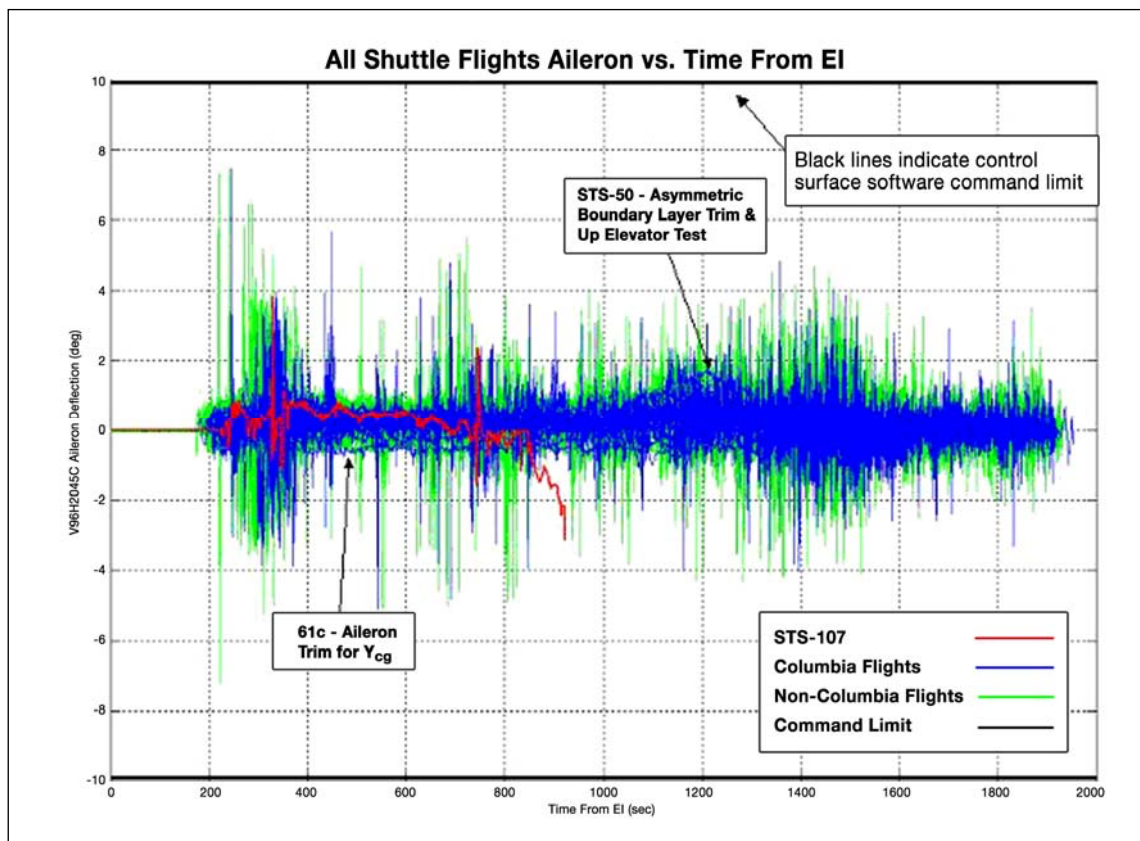
Figure 1.1-11. The sharp divergence from previous flight experience starts at approximately GMT 13:58:19 (EI+850).¹²

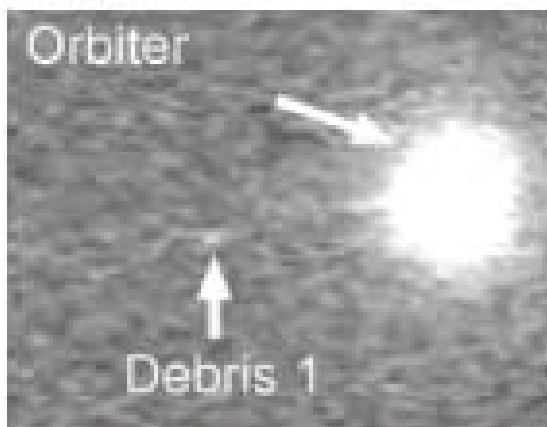
The first known debris shedding event on entry was identified as Debris 1 and most likely originated from the left wing. Debris 1 becomes visible on ground-based video at GMT 13:53:46 (EI+577). Later ballistic analysis estimated a release time of GMT 13:53:44.8 (EI+575).¹⁵ Luminosity measurements and calculated rates of deceleration were used to determine that the mass was < 8 lbs.¹⁶ Figure 1.1-13 shows the orbiter and the debris.

Figure 1.1-13. Video capture of the first observed incident of debris being shed. The orbiter is traveling from left to right in this image.

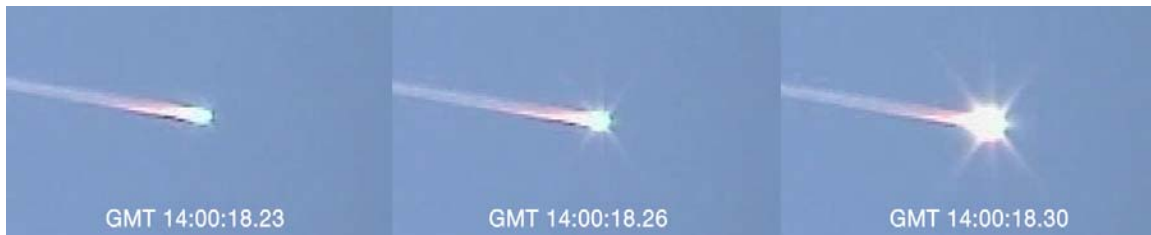
At GMT 14:00:18 (EI+969), video showed that a significant event (the CE) occurred to the orbiter (figure 1.1-24). The GPS Miniaturized Airborne Global Receiver (MAGR) experiment, which was located in the middeck and powered by a fuel cell in the payload bay, experienced a loss of power at the CE. Less than 1 second later, the MADS/OEX recorder, which was also located in the crew module and similarly powered from the payload bay, also experienced a total power loss. The conclusion was that the forward and midbody orbiter segments separated at the CE. The CE is actually the start of a period of several seconds in which the orbiter underwent a major structural breakup. At GMT 14:00:25 (EI+976), there were visual indications that the orbiter was in multiple pieces. Ballistics analysis and structural debris analysis supports this period as the breakup event.

Figure 1.1-24. The Catastrophic Event is depicted in these three frames of video that cover 0.1 second. There is no change in the magnification/zoom factor. The third frame represents GMT 14:00:18.3 (EI+969).

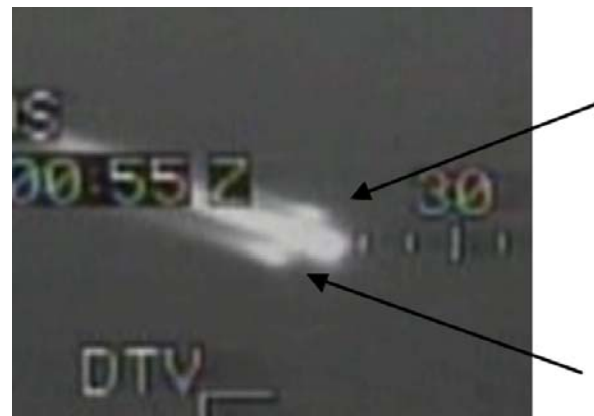
Figure 1.1-30. Video frame from the Apache video at GMT 14:00:55 (EI+1006) showing two similar luminosity objects separating from the forebody.

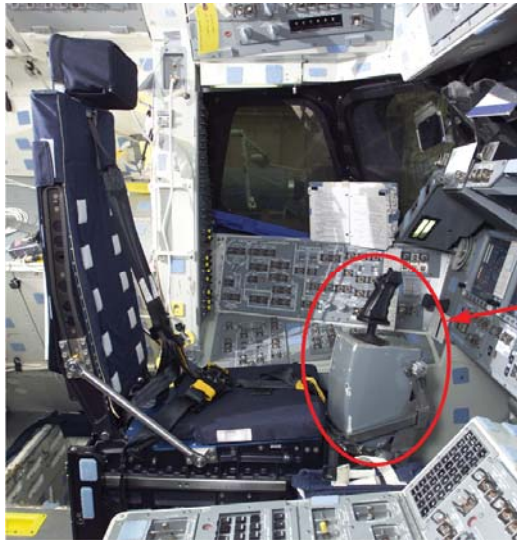
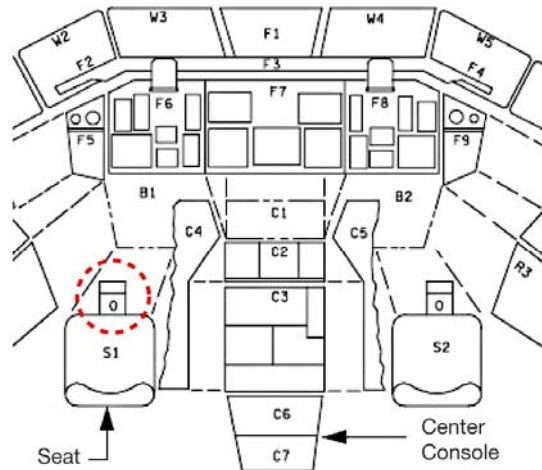
Between GMT 13:36:04 (EI-485) and GMT 13:36:06 (EI-483), the CDR/Seat 1 is performing entry preparation actions that lead to the RHC being bumped (figure 1.2-6).

Figure 1.2-6. Location of Commander's seat and rotational hand controller. [Left picture from the Shuttle Training Simulator looking from starboard to port; right picture adapted from the Space Shuttle Systems Handbook looking from aft to forward]

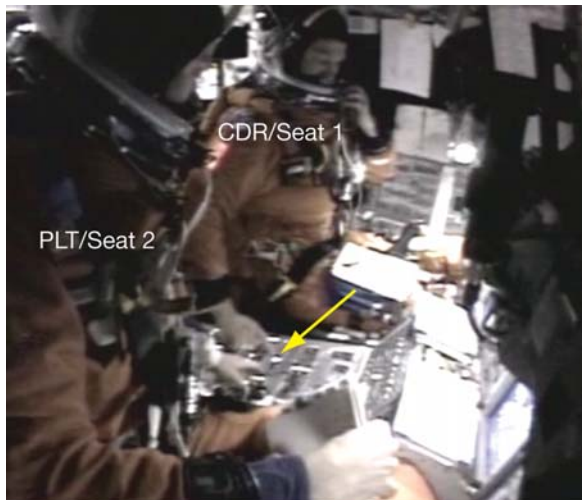
DAP DNMODE RHC. Primary Avionics Software System (PASS) DAP DOWNMODE RHC (time from telemetry analysis). The message indicates that the RHC movement in the previous event was sufficient to mode the DAP out of AUTO into Inertial mode. When this occurs, a "DAP DOWNMODE RHC" caution and warning message is displayed, the INRTL button on the C3 panel is illuminated (see arrow in figure 1.2-7), and a tone, which can be heard in the recovered video tape, is annunciated (figure 1.2-7).

Figure 1.2-7. Digital autopilot button on the C3 panel is illuminated.

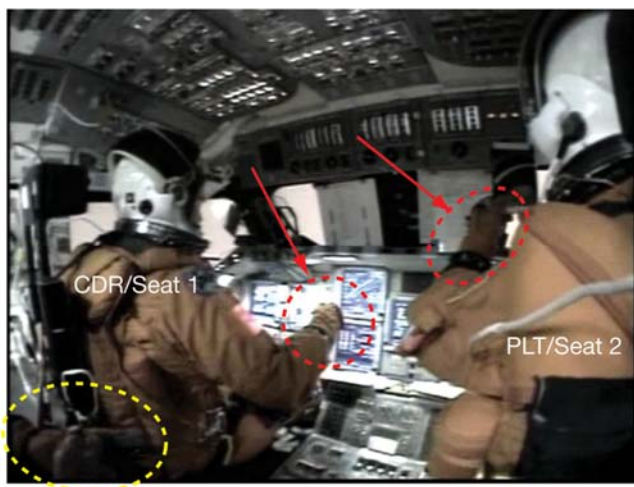
CDR/Seat 1 and PLT/Seat 2 are observed with gloves still ON and MATED (red circles in figure below), visors OPEN. MS2/Seat 4 is observed starting to don gloves (yellow circle in figure) and is also observed with left glove ON but NOT MATED and right glove OFF (figure 1.2-14).

Figure 1.2-14. Mission Specialist 2/Seat 4 donning left glove; Commander/Seat 1 and Pilot/Seat 2 with gloves ON and MATED.

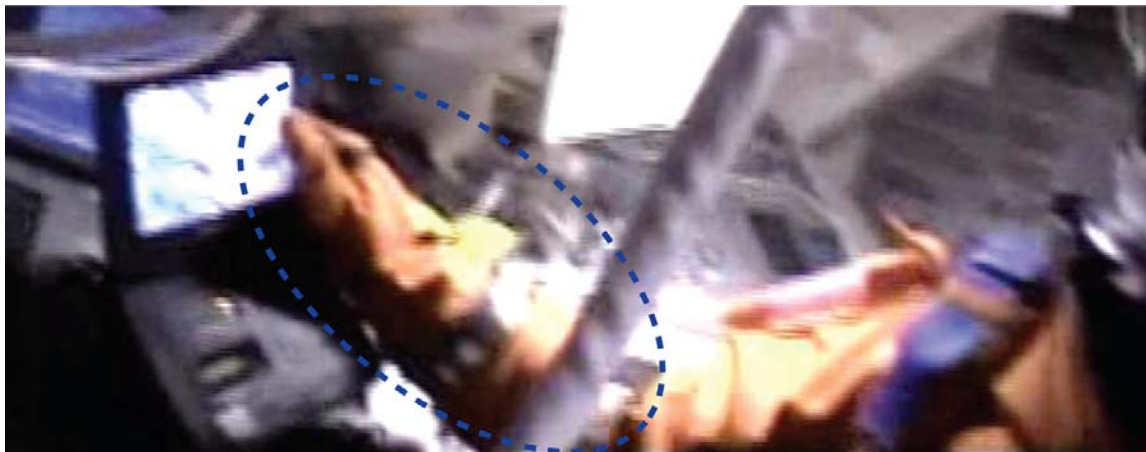
MS4/Seat 3 with right glove still ON and MATED (figure 1.2-15).

Figure 1.2-15. Mission Specialist 4/Seat 3 right glove still ON and MATED.

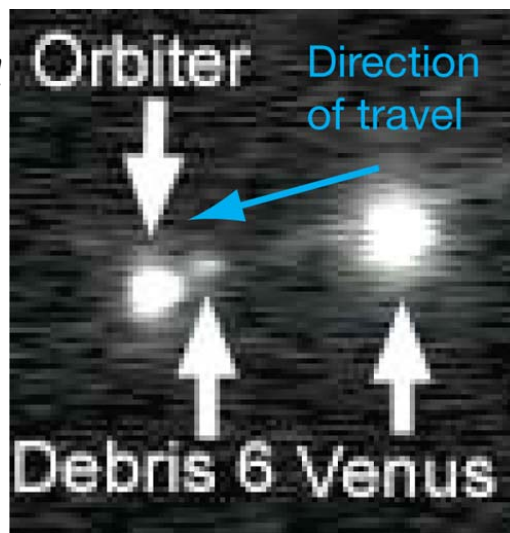
Debris 6 released. The brightest debris-shedding event occurring in this phase, Debris 6, is first visible on video at GMT 13:54:36 (EI+627) (figure 1.2-28). Ballistic estimates determined that the actual release time was 4 seconds earlier. Luminosity measurements and calculated rates of deceleration were used to determine that the mass was probably a few hundred pounds. ⁷ There were no data from sensors, instrumental indications, or apparent crew recognition of this debris loss.

Figure 1.2-28. The brightest debris event known to have occurred prior to loss of signal. The orbiter is traveling from right to left.

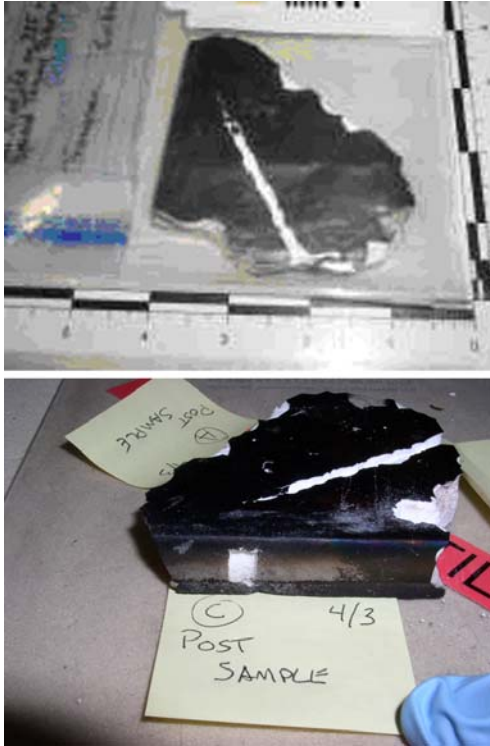
<p>Alt = 212,007 feet [Master Timeline, Rev. 15 Baseline] Mach = 19.77 [Master Timeline, Rev. 15 Baseline] Qbar = ~54 psf [modeling]</p>
13:58:12 (EI+843)	<p>End of ground-based video coverage for western portion of entry.</p>
13:58:21(EI+852) ±5 sec	<p>Littlefield Tile Released. This piece of tile was recovered in Littlefield, Texas; it is the westernmost piece of recovered debris (figure 1.2-35).</p>

Figure 1.2-35. *The Littlefield tile.* [Picture from the Columbia Reconstruction Database, debris item no. 14768]

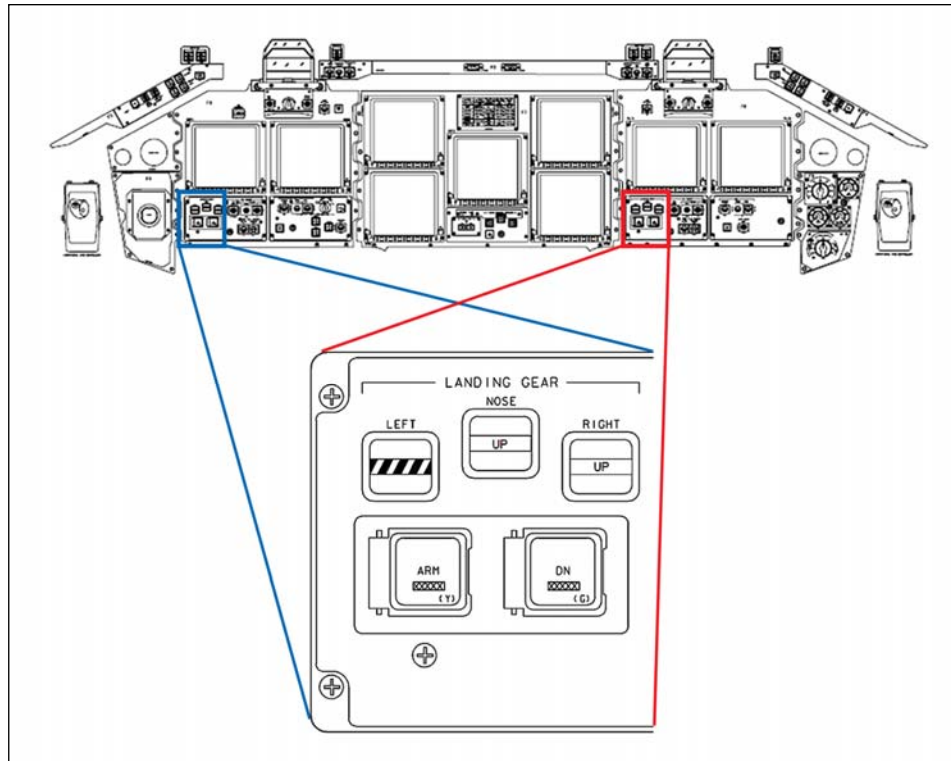
Figure 1.2-36. Landing gear indicator panel, identical on both sides of the flight deck forward display panels. Left indicator showing “barber pole” (indeterminate position). [Adapted from the Space Shuttle Systems Handbook]

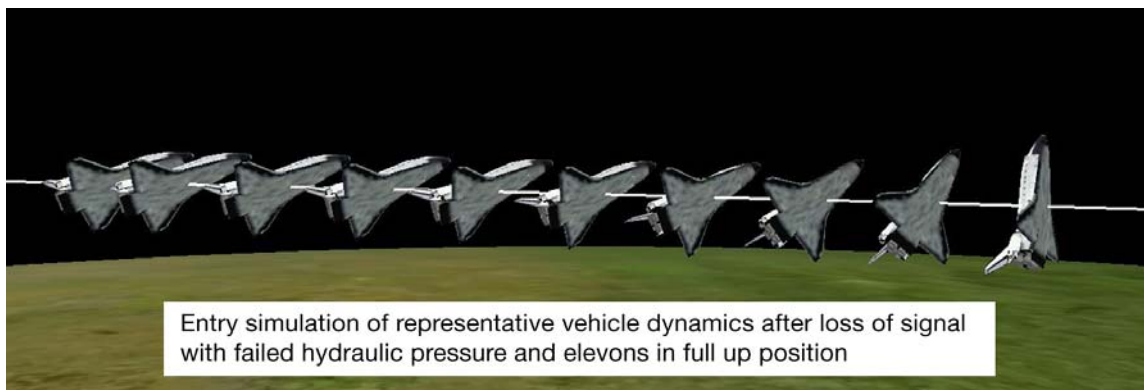
Beginning of the Orbiter Pitch-up. Based on the time of the ROLL REF message (GMT 13:59:46 (EI+937)) and the divergence from the drag profile required to generate the ROLL REF alarm, this is the probable time that control was lost due to the probable loss of hydraulic pressure to the control surfaces. The loss of hydraulic pressure would have resulted in a Master Alarm being annunciated and the orbiter pitching up. While the drag had yet to diverge out of bounds of the drag profile, the orbiter was no longer in controlled flight. This marks the beginning of the transition from a controlled glide to an uncontrolled ballistic entry. Orbiter heating, lift, and drag would no longer be controlled, the ballistic number would be constantly changing with the changing attitudes, and downrange control would be lost (figure 1.2-40).

Figure 1.2-40. Sequence (1-second intervals) showing a simulation of orbiter loss of control pitch-up from GMT 13:59:37 (EI+928) to GMT 13:59:46 (EI+937). White line indicates vehicle trajectory relative to the ground.

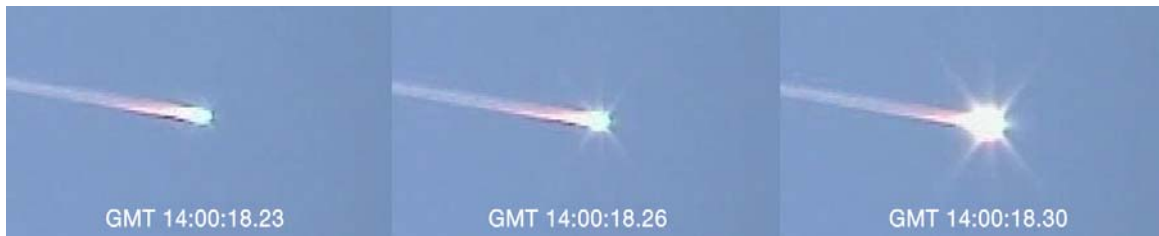
CATASTROPHIC EVENT. The CE is a period of time during which the orbiter vehicle is undergoing a major structural breakup. At this time, the accelerations on the forebody were estimated to be 3.5 Gs. The breakup sequence progressed over several seconds. Analysis of ground-based video of the event established the first detectable signs at GMT 14:00:18 (EI+969). Based on engineering analysis, the CE is thought to have started with the compromise of the PLBDs, exposing the payload bay longeron sill to entry heating. The skin splice between the midbody and the X₀ 582 ring frame bulkhead area, aft of the starboard x-link, failed due to a combination of mechanical and thermal loads. The forebody rotated away from starboard to port, causing the port x-link to fail due to bending loads. As the forebody separated from the midbody, various power, data, and ECLSS lines failed and the crew module was free to move forward and strike the inside of the forward fuselage. At GMT 14:00:25 (EI+976), the separated forebody is marginally visible. The CE is further supported by a collection of evidence that includes ground-based video of a large debris-generating event, the loss of the MADS/OEX recorder function, and the debris footprint (figures 1.2-43 and 1.2-44).

Figure 1.2-43. The Catastrophic Event is depicted in these three frames of video that cover 0.1 second. There is no change in the magnification/zoom factor. The third frame represents GMT 14:00:18.3 (EI+969.3).

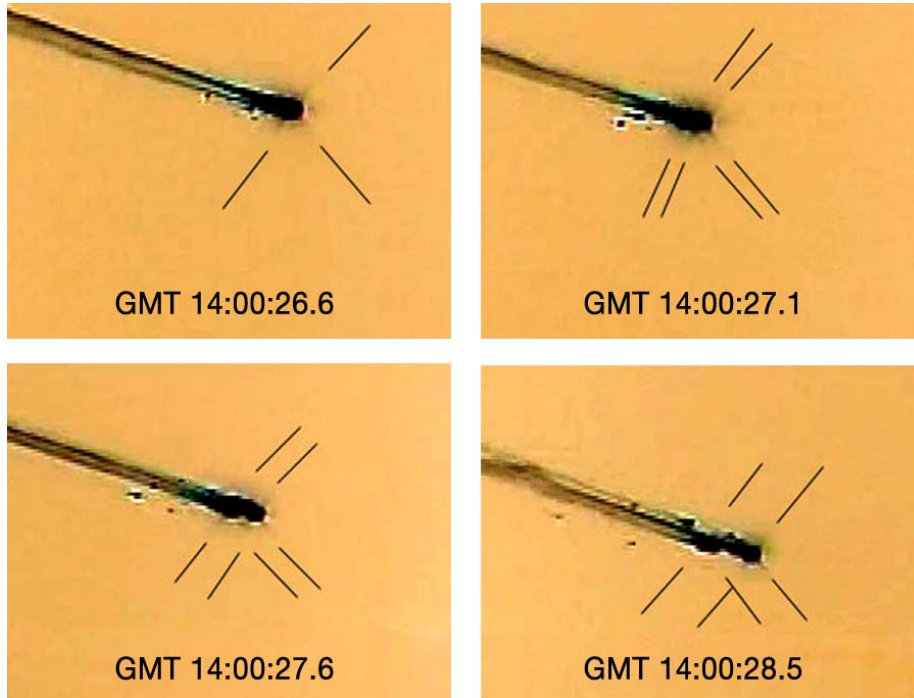
First visual indication that the orbiter had broken into multiple pieces (figure 1.2-46).

Figure 1.2-46. Color-inverted video images of the start of the double star event, GMT 14:00:26.6 (EI+977.6). Black lines have been added to more clearly identify the two separate objects.

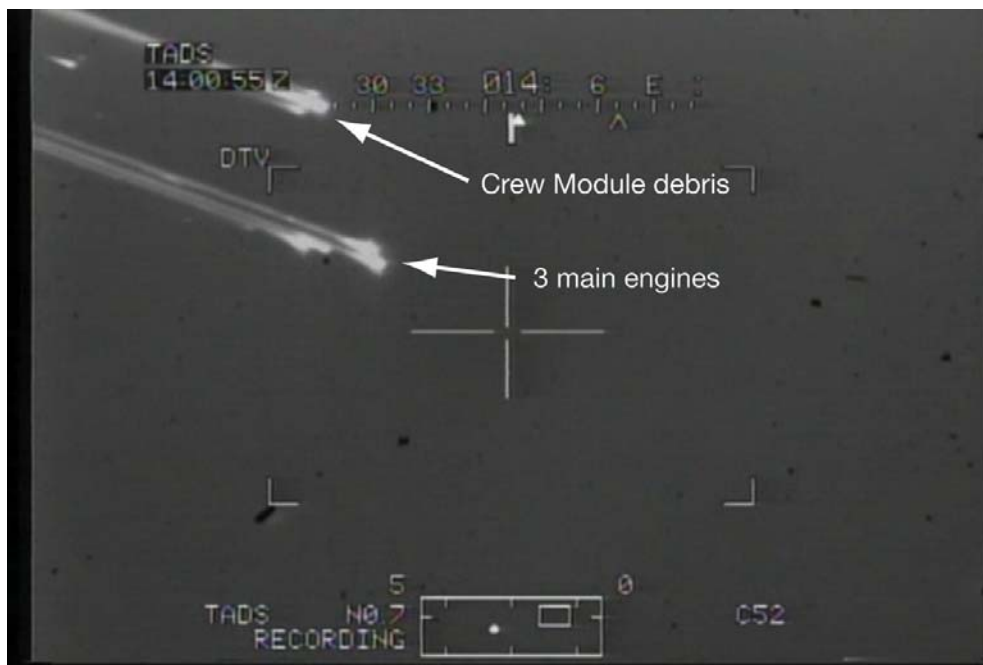
CREW MODULE CATASTROPHIC EVENT Begins. The CMCE is the initiation of a period of time during which the forebody was undergoing a major structural breakup. The breakup sequence progressed over several seconds and ends at approximately GMT 14:01:10 (EI+1021). Analysis of ground-based video of the event established the first detectable signs at GMT 14:00:53 (EI+1004). Based on engineering analysis, CMCE is thought to have started with the failure of the forward fuselage. Once the forward fuselage began to break away, the exposed crew module rapidly failed due to the combined effects of the high G-loads, aerodynamic forces, and thermal loads. The flight deck maintained structural integrity longer than the middeck (figure 1.2-47).
--------------------	--

Figure 1.2-47. Image from Apache³⁵ video showing crew module debris (top cluster) and the three main engines (cluster to left of cross hairs).

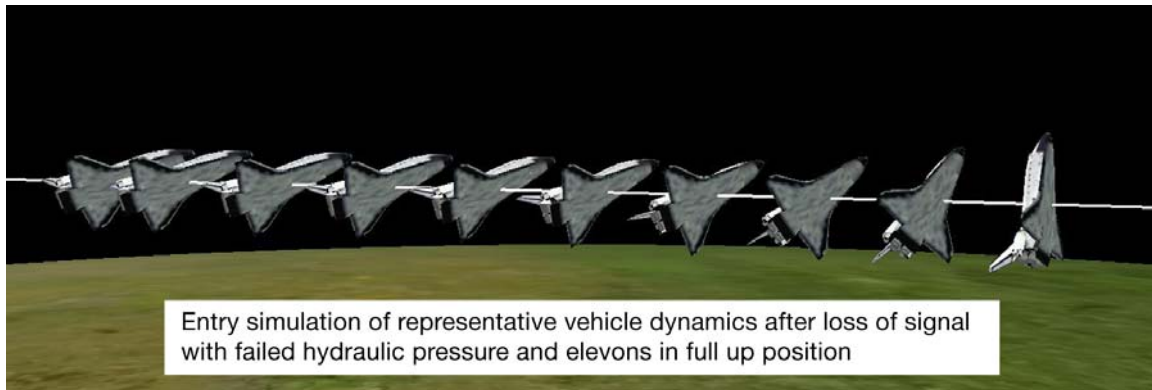
It was concluded that the most credible scenario for LOC was the loss of all hydraulic systems, causing the aerosurfaces to float and resulting in an uncontrolled pitch-up. Since the left wing contains locations where all three hydraulic systems have lines that are in close proximity (including the left gear well), it is probable that the loss of hydraulics was due to thermal damage as a result of the breach in the wing. Consequently, the SCSIT defined the vehicle LOC to begin at GMT 13:59:37, immediately after the LOS, when it was determined by inference that hydraulic power to the aerosurfaces was lost. Prior to this time, *Columbia's* DAP was still in control of the orbiter. The FCS was commanding the elevons and the RCS yaw jets to counteract the increasing drag on the damaged left wing. The LOC marks the time when the *ability* to control the vehicle was lost, not when *Columbia* departed known attitudes (which occurred shortly thereafter).

Figure 2.1-7 shows the increasing angle-of-attack simulation. The figure shows the orbiter attitude at 1-second intervals, beginning at GMT 13:59:37 and ending at GMT 13:59:46. The white line in the figure is the reference trajectory.

Figure 2.1-7. Sequence (1-second intervals) showing a simulation of orbiter loss of control pitch-up from GMT 13:59:37 to GMT 13:59:46. White line indicates vehicle trajectory relative to the ground.

Recommendation L3-2. Future vehicles should be designed with a separation of critical functions to the maximum extent possible and robust protection for individual functional components when separation is not practical.

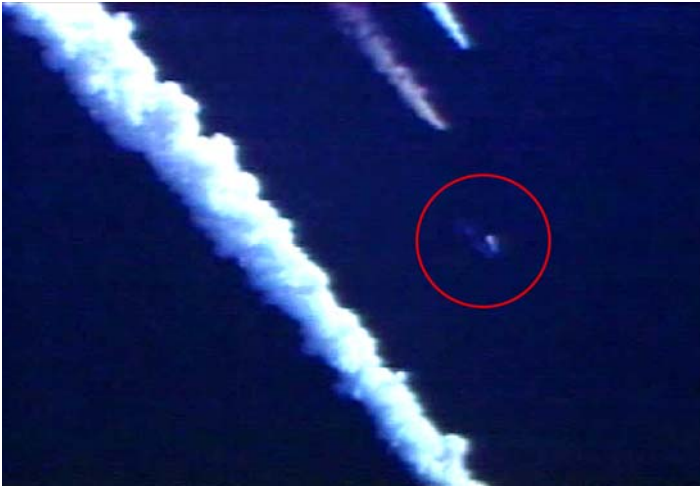
The SCSIT received anecdotal information that the *Challenger* CM was believed to have reached a stable attitude (“trimmed”) in a nose-into-the-wind condition. This belief was based on a video that shows a brief clear view of the CM in this orientation (figure 2.1-19), and the fact that the CM appeared to have impacted the water in a slightly nose-down condition.¹² As a result, the assumption upon which crew procedures are based (see Section 3.3) was that in an LOC/breakup scenario, the CM would trim nose-down after reaching terminal velocity. Although many types of data regarding the *Challenger* accident are available, they are almost entirely limited to information about the cause of the accident and are not related to crew survival. Relevant information was generally located by contacting personnel who worked at NASA at the time. No data could be found to support this anecdotal conclusion other than the video. Ground-based video of the forebody of *Columbia* implied that the forebody was rotating. Consequently, the SCSIT set out to assess the assumption that the *Columbia* forebody came to an aerodynamically stable attitude.

Figure 2.1-19. Video-capture showing Challenger crew module (circled in red) pointed nose into the direction of travel.

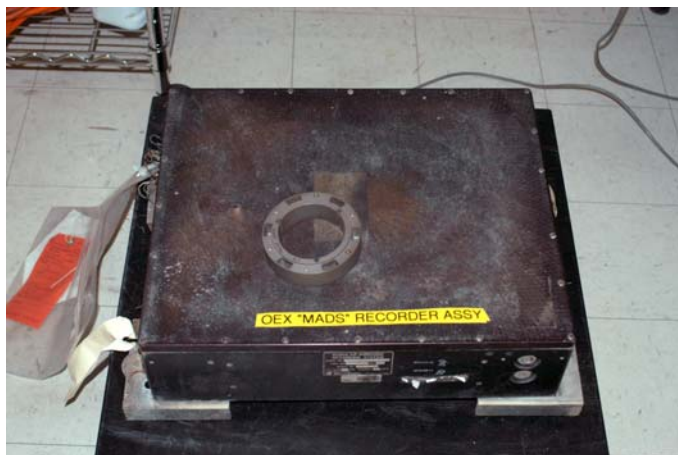
The OEX recorder, which was part of *Columbia*’s MADS, was found near Hemphill, Texas in near-perfect condition. Figure 2.1-44 shows the recovered OEX recorder. The data on the tape in this recorder were critical to the accident investigation, making the recorder one of the most important recovered items from *Columbia*.

Figure 2.1-44. Recovered orbiter experiment recorder from STS-107. [Columbia Reconstruction Database, debris item no. 54057]

The rectangular shape of the box made it a good candidate for ballistic analysis providing a release time with high confidence. The box showed no signs of thermal erosion or exposure to high temperature environment. Text labels that have been imprinted on the box still remain. The data that were recovered from the recorder were recorded on magnetic tape that delaminates at 125°F (52°C). An analysis was performed to estimate the thermal damage that a free-flying OEX recorder would receive due to aerothermal heating after release from inside the CM.

The lack of external thermal damage is quite noteworthy. Anodizing is still mostly present, as are the exterior labels. Exposed wires still have insulation. Finally, since aluminum is a good conductor it is expected that the internal wall temperature would have been close to the surface temperature. Since the recorder’s magnetic tape delaminates at 125°F (52°C), this also suggests that the aluminum may not have reached the predicted high temperature of 470°F (243°C).

The conclusion is that the OEX recorder was not released from the CM independently. If the temperatures reached as high as predicted, the magnetic tape would have delaminated and the casing would have likely been deformed. This analysis combined with the relatively pristine condition of the recorder seems to imply that something must have protected the recorder during entry before it was completely exposed to the aero-thermal heating environment. Ultimately, no conclusion can be made as to what ancillary structure or other mechanism protected the OEX, only that it was protected.

Recommendation L3-3. Future spacecraft design should incorporate crashworthy, locatable data recorders for accident/incident flight reconstruction.

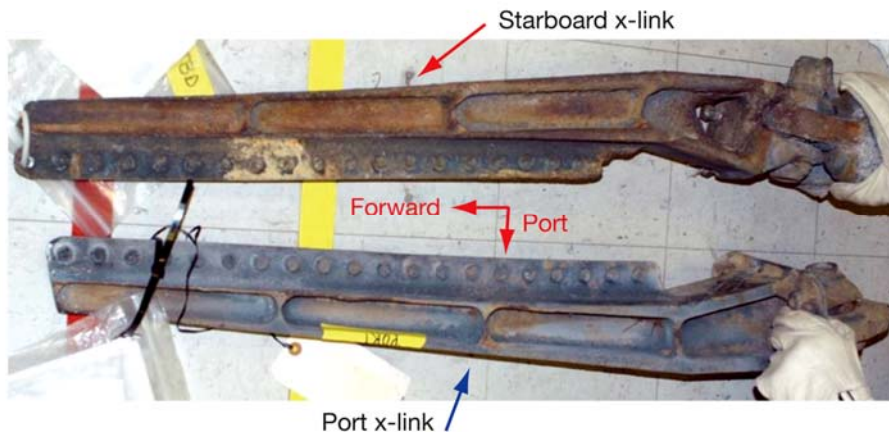
Figure 2.1-47. Comparison of port and starboard x-links recovered from Columbia. [Columbia Reconstruction Database, debris item no. 1678, and Columbia Reconstruction Database, debris item no. 1765]

The heating experienced by the starboard x-link was severe enough to melt away the top flange and to burn a hole through the 0.25-in.-thick web. Figure 2.1-48 shows another comparison of the two x-links with a better viewing angle to see the flange damage. Figure 2.1-49 shows a close-up view of the starboard x-link where a hole has been melted through the web.

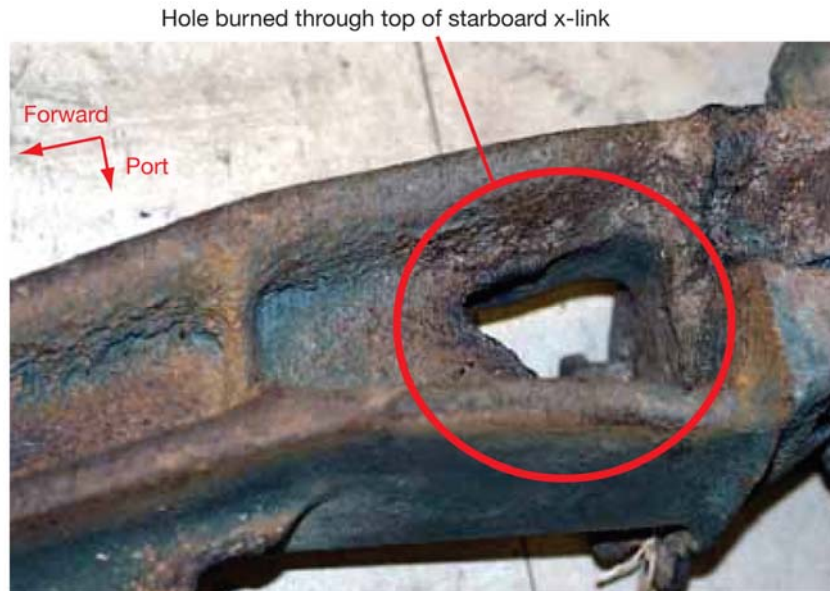
Figure 2.1-49. Close-up of the hole in the starboard x-link. [Columbia Reconstruction Database, debris item no. 1765]

Knowing the heat of ablation per unit of mass allows a first-order estimate of the required heating that must be applied to cause that burn-through hole in the starboard x-link. The dimensions of the burn-through area are 2 in. by 2 in. and the thickness of the x-link in that area is 0.25 in.

Finding. Thermal analyses predicted that entry aeroheating alone was insufficient by an order of magnitude to produce the observed thermal damage on the x-links. Therefore, the x-links must have experienced other heating mechanism(s) in addition to normal entry heating.

Conclusion A13-2. The heating from a Type IV shock-shock impingement and titanium combustion (in some combination) likely resulted in the damage seen by the forward payload bay door rollers and the x-links.

Recommendation A13. Studies should be performed to further characterize the material behavior of titanium in entry environments to better understand optimal space applications of this material.

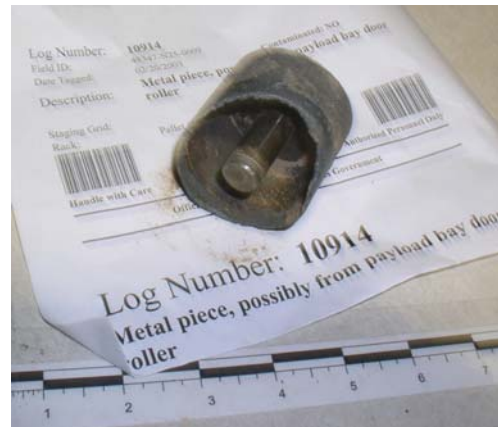
Another instance of the thermal erosion of high-temperature materials was seen in the PLBD rollers, which contain notable amounts of titanium. Initially, the interest in the PLBD rollers resulted from a search of possible sources for the titanium deposition that was found on the overhead windows (see Section 2.4).¹⁸ A search for forward structures containing titanium showed that the nearest source of titanium material to the windows was the forward PLBD rollers. These rollers are made of aluminum, titanium, and an Inconel sleeve, and the PLBDs rest on them when the doors are closed. The forward rollers are attached to the top of X_o 582 ring frame bulkhead in close proximity to the windows on which the titanium depositions were found (figure 2.1-52). Several recovered rollers from this location showed pronounced erosion of the exposed titanium surfaces, and one roller was recovered with only part of the Inconel sleeve remaining; all titanium and aluminum inner structures were missing (figure 2.1-53). Table 2.1-2 shows the material properties of stainless steel (A286), Inconel 718, aluminum 2000 series, and titanium 6Al-4V. As shown, the Inconel and aluminum alloys used in the rollers both have lower melting temperatures than the titanium alloy.

Figure 2.1-53. Recovered payload cylinder bay door roller with inner material absent and Inconel sleeve remaining. [Columbia Reconstruction Database, debris item no. 10914]

The next question was whether the observed amount of material loss was reasonable for the timeframe. As mentioned before, heating only occurs when the object is facing into the direction of travel, yet it is not believed that the forebody stabilized in a specific attitude. Additionally, the nature of the window deposition indicates that the titanium and titanium/aluminum deposition event was continuous and not cyclical. Therefore, the entire titanium/titanium aluminum ablation event had to occur in a relatively short period of time. Given an attitude change of approximately 36 deg/sec (0.1 rev/sec), the maximum duration of heating considered reasonable was about 3 seconds. In any attitude other than directly into the velocity vector, heating is less but is still present. Therefore, the CFD analysis only showed the peak heat was possible. It seems probable that some additional mechanism would be required to deeply erode the rollers.

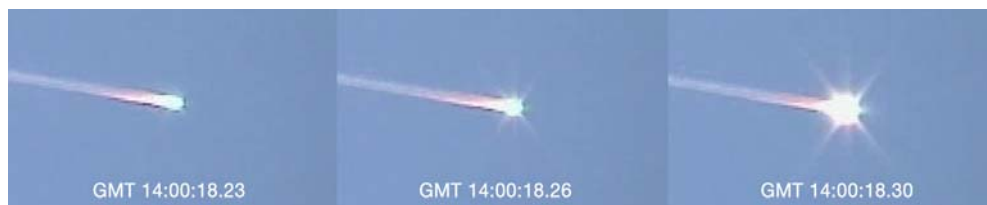
The second significant event that is seen in video is the CE. Figure 2.2-5 shows the CE; there is no change in magnification between frames. The video of the CE is a distinct visual event in which the orbiter envelope brightens significantly and the trail width doubles. Additionally, some color change to orange is evident just prior to the CE. The color change is not readily visible in the still image frames that are taken from the video. In videos of the *Challenger* accident, an orange color was also seen in the videos and was assumed to be hydrazine, the material that is contained in the Orbital Maneuvering System (OMS) pods and RCS tanks. It is unknown whether the orange color seen in *Columbia*'s trail correlates to OMS or RCS tanks, or to some other cause.

Figure 2.2-5. The Catastrophic Event is depicted in these three frames of video that cover 0.1 second. There is no change in the magnification/zoom factor. The third frame represents GMT 14:00:18.3.

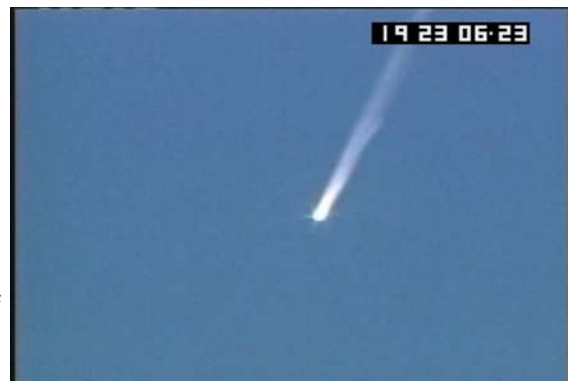
Shortly after the brightening event and color change, a split trail is seen (figure 2.2-6). This strongly supports that the orbiter broke into multiple pieces at the time of the CE. The NBC video shows that the orbiter has an intermittent split trail prior to the CE. Prior to the CE, the split trails are tied to the separation of pieces of debris, and a singular main body trail continues after the separation of the debris. The split trail seen after the CE is constant; it does not dissipate and does not resolve back to a singular trail (figure 2.2-7).

Figure 2.2-7. Persistence of the split trail 23 seconds after the Catastrophic Event. [GMT 14:00:41.1]

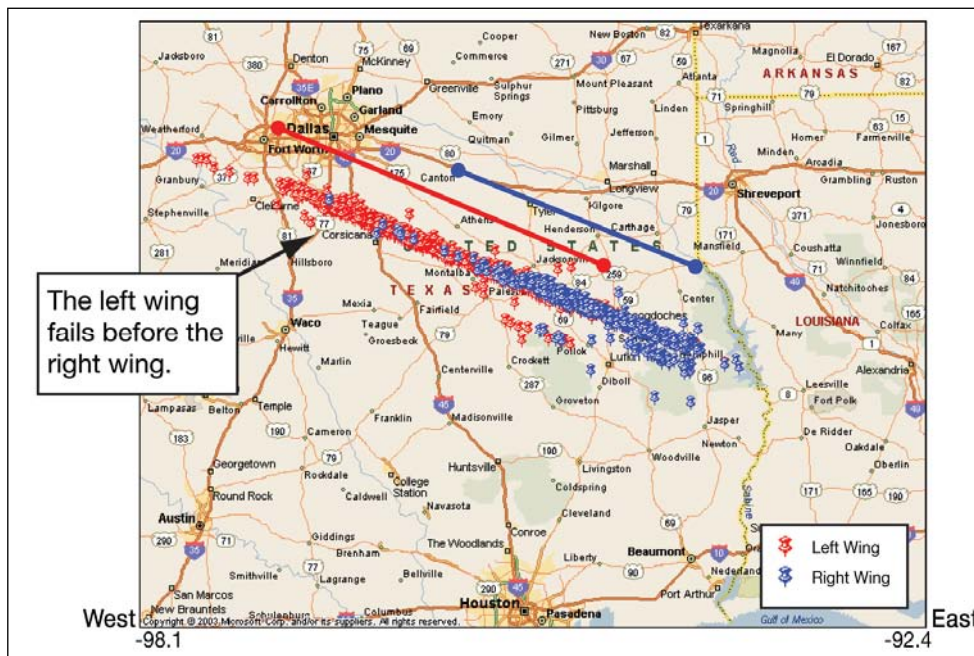
Figure 2.2-12 identifies where the wing structure is in relationship to the other orbiter structural components. TPS tile is included in these figures, as some tile adhered to structure and it was not easily possible to separate out individual tiles. Figure 2.2-13 shows a ground debris map that is similar to that produced in the CAIB Report, Volume I, p. 75; however, figure 2.2-13 shows all the debris for the wings whereas the CAIB map shows only the RCC panels. As the CAIB reported, the left wing failed before the right wing. This is implied in figure 2.2-14 as well. Overlay mapping of debris at their correct latitudes and longitudes prevents easy recognition of their actual ground footprints. The bars shown on the map and in later ground debris maps represent the main cluster of the debris. If coverage extends beyond the map shown, an arrow indicates that the footprint continues off the map. The bar shown above each histogram indicates the longitude range covered by the overlay mapping.

Figure 2.2-13. Debris field of the left and right wings.

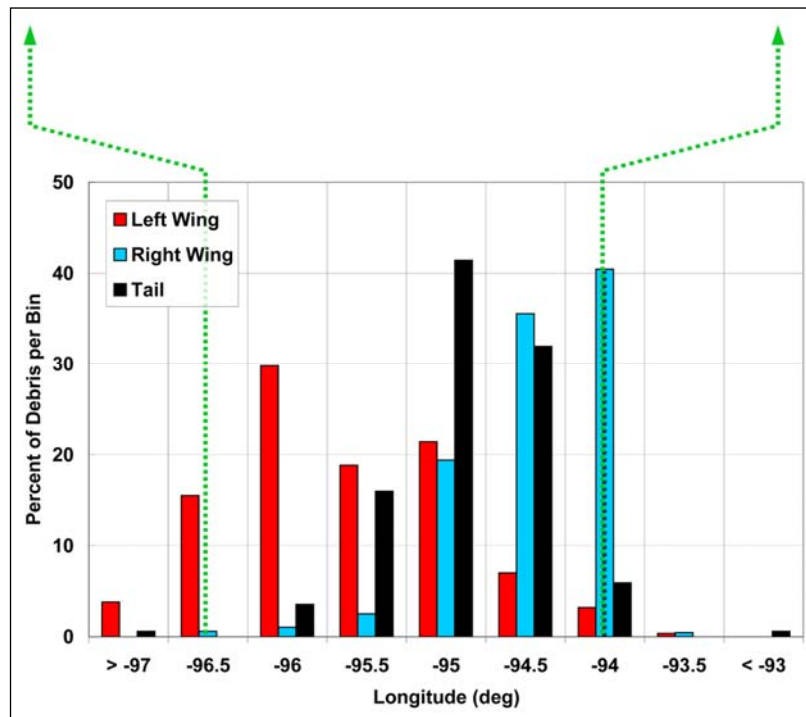
Figure 2.2-14 illustrates the debris of the tail section in relation to the wing debris. The bulk of the tail debris impacted west of the bulk of the right wing debris. Figure 2.2-15, which is a histogram of longitude vs. the number of debris items, shows this as well. The lines above the histogram indicate the approximate area of the histogram that the debris map covers. Figure 2.2-15 suggests that the tail possibly began to depart between the left wing and the right wing.

Figure 2.2-15. Histogram of the left wing, right wing, and tail debris. The green dotted lines are the projection onto the histogram of the longitude range shown in the map.

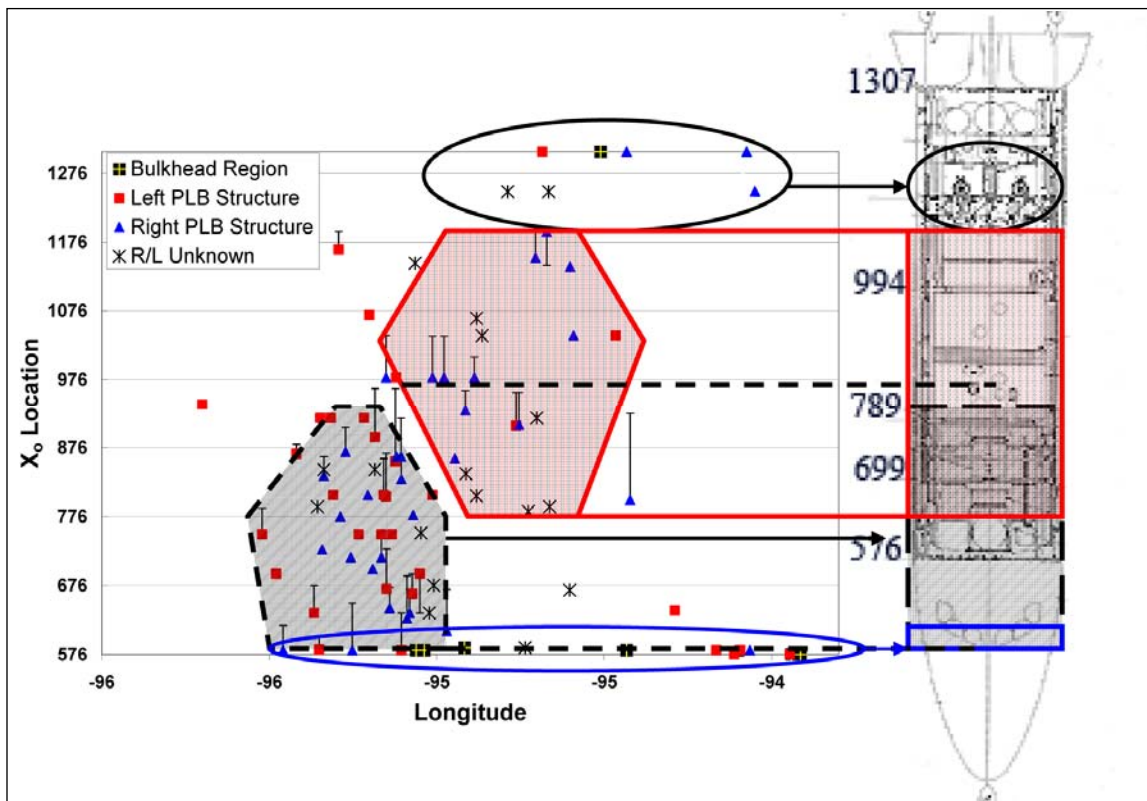
The westernmost piece of ground debris from the midbody structure with a known X_o location was a port location just aft of SPACEHAB. However, this appears to be an outlier data point. Figure 2.2-18 indicates that based upon recovered midbody structure, the midbody first suffered a major failure ranging from about X_o 582" to X_o 919".

The next grouping of debris predominantly originates from X_o 776" (towards the aft of SPACEHAB) to aft of the Fast Reaction Experiments Enabling Science, Technology, Applications, and Research (FREESTAR) payload near X_o 1124", although there are a few pieces near the forebody bulkhead (X_o 582").

The final cluster is from the aft region of the midbody. As debris originating from near the midbody aft bulkhead (X_o 1307") appears farthest east in the debris field, this suggests that some midbody payload bay structure remained attached to the aftbody.

Figure 2.2-18. Longitude vs. the X_o origin of the structural debris of the mid fuselage. To the right is a drawing of the mid fuselage with key X_o positions marked.

The data in figure 2.2-18 cannot be used to determine a port or starboard initiation of breakup of the midbody. Size of individual items was also examined with the assumption that ballistic numbers of objects of roughly the same size and shape will land in the order in which they separate from the orbiter. The number

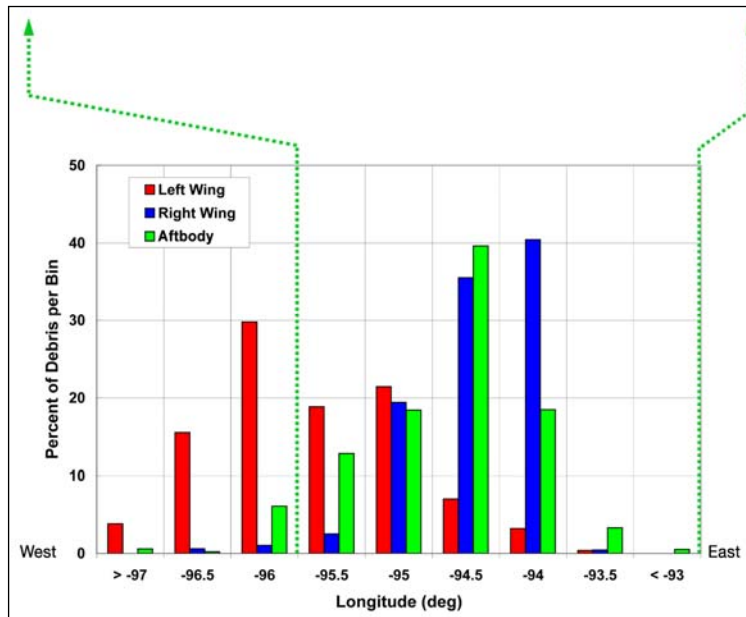
Figure 2.2-20. Histogram of debris of the wings and aftbody (including orbiter main engines). The green dotted lines are the projection onto the histogram of the longitude range shown in the map.

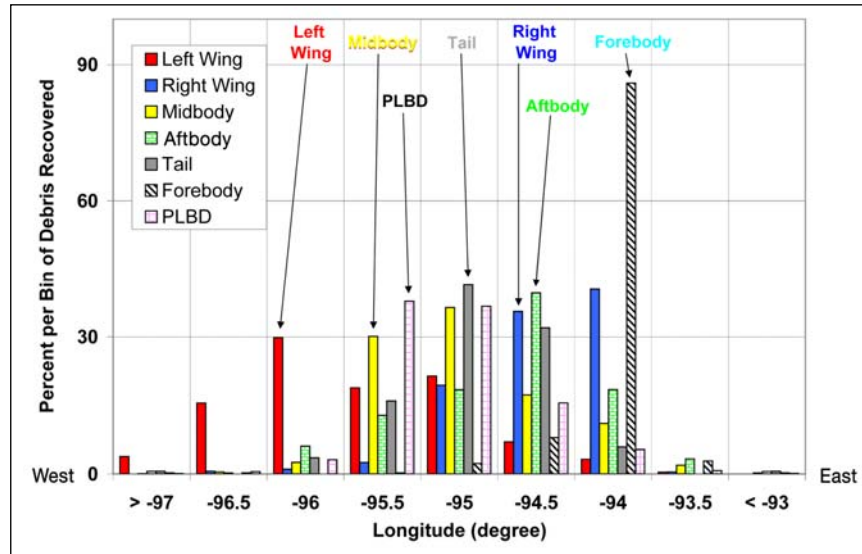
In summary, figure 2.2-21 shows an overall assessment of debris clusters. The westernmost longitude bin of each group that exceeded 30% of the recovered debris group is referenced with an arrow; the label above the bin identifies the debris group. It was observed that when the number of recovered debris items from one orbiter structural zone reached approximately 30%, the next group began to appear in rapidly increasing numbers. The significance of this observation is not known. It may be an artifact of data processing, or it may be characteristic of a cascade effect of structural breakup. This is a topic that may warrant further research and investigation.

Figure 2.2-21. Histogram of the relative order of the major debris groups recovered.

There was no evidence from the ballistic or debris cluster analysis that the forebody suffered any major breach before it separated from the midbody. Figure 2.2-21 (in the debris cluster assessment section) shows that forebody debris does not begin to appear in the debris field until other midbody debris is present in large quantities.

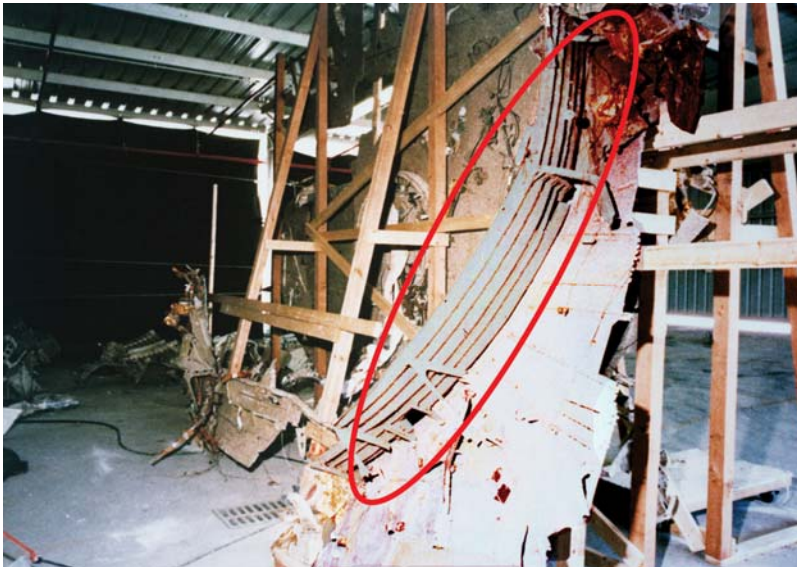
However, the SCSIT review of *Challenger* debris photographs clearly showed that part of the X_o 582 ring frame bulkhead was recovered with the *Challenger* X_o 576 bulkhead debris (figure 2.2-30).

Figure 2.2-30. Recovered X_o 576 bulkhead of the *Challenger* crew module showing a portion of the X_o 582 ring frame bulkhead (circled in red).

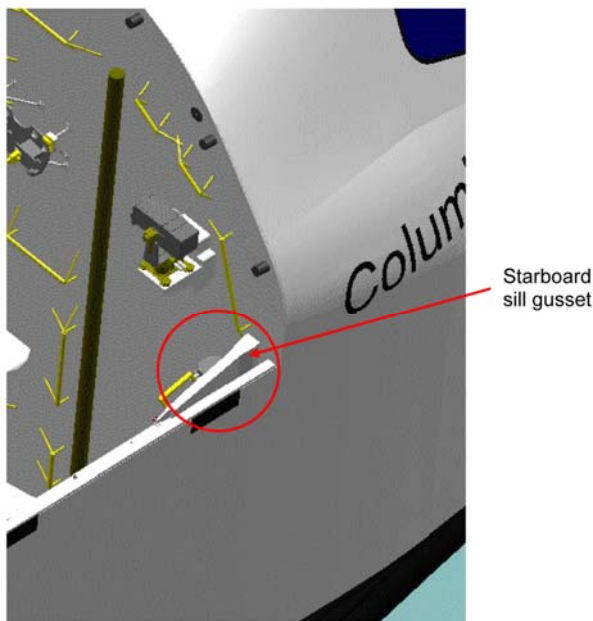
Without the PLBDs, the weak zone between the forebody and the midbody is the sill joint gusset on the aft side of the X_o 582 ring frame bulkhead (figure 2.2-31). This gusset is an offset structural connection that transfers the major X-axis loads from the CM to the midbody sill longeron via the x-links.

Figure 2.2-31. Close-up of the starboard sill gusset area.

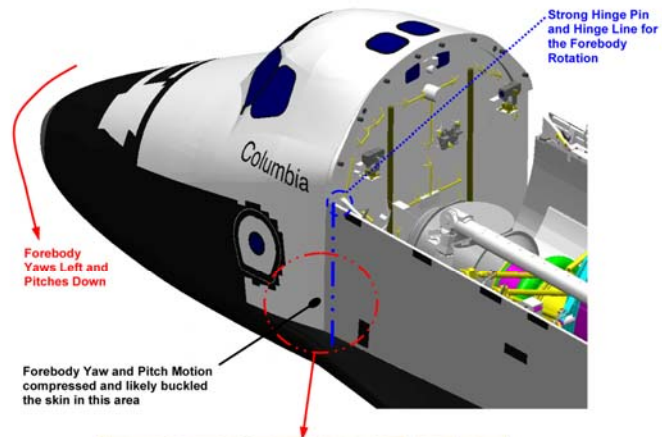
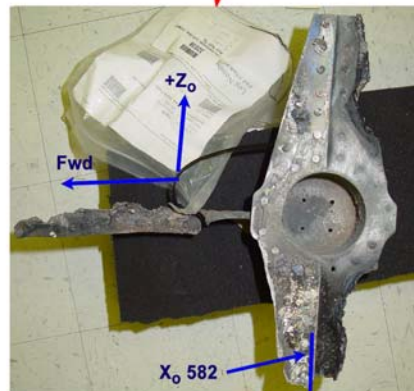
The condition of the recovered forward portside hoist fitting (figure 2.2-34) indicates that the Xo 582 ring frame bulkhead likely broke away from the midbody skin via mechanical failure, prior to any thermal effects. The Bay 1 side skin pulled away because of mechanical failure. The midbody skin splice severed the fasteners from the titanium hoist fitting by mechanical force, some Hilok bolts were cut off, and some flush bolt heads pulled through the skin splice. This damage, which may have occurred at the CE, suggests that the forebody yawed left and pitched down relative to the midbody. This motion may also have broken the port x-link lug (discussed in the next section). This kind of mechanical failure could only happen when the hoist fitting was still attached to the FF, when sufficient mass existed to exert this level of force.

Figure 2.2-34. Forward port hoist fitting, Columbia Reconstruction Database debris item no. 32038.

Unlike the starboard hoist fitting, the skin panel forward of the port hoist fitting was not recovered. One possible explanation is that the FF skin on the forward side of this item was deformed or wrinkled by compression loading at the CE when the forebody yawed left and pitched down. This may be supported by the fact that the port forward hoist fitting was recovered in the middle of the forebody debris field while the starboard hoist fitting was found in the western end of the debris field. Wrinkled skin most likely debonded TPS tiles, so this area would be subjected to thermal flow damage on at least the skin-side surface starting at the CE, then on both sides after it departed from the forebody after the CMCE. Alternatively, the port area may have simply stayed intact longer and received more entry heating following the CMCE.
